## EDGEHILL LIGHT RAILWAY IN IMAGES

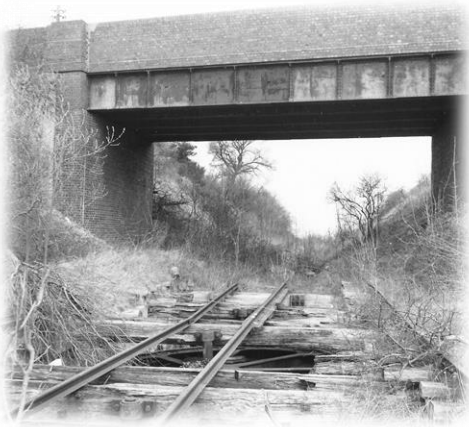
Photograph showing Camp Lane Bridge with steel plate girder and brick abutments and parapets. Taken looking towards the north, standing next to the wheel pit that contained three brake wheels set with vertical axles. The three top bearings for these axles and remains of three tracks can be seen. In use, the pit was covered by timber beams and planks.

The bridge was demolished soon after the photograph was taken and the gap filled in. Rumour has it that only the parapets were removed and the bridge is still there, under the present road. It is assumed the wheels were removed at the same time. The pit is probably still there, full of soil.

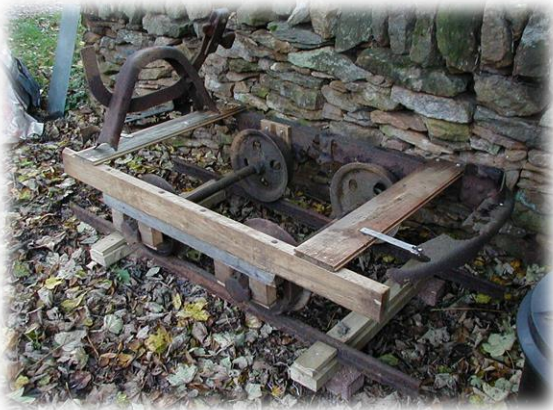
Rescued 2ft narrow gauge tipper truck with roller bearing boxes by Hudson's of Leeds. The rescued truck shows an end frame, with latch to hold and release the hopper. Tipper trucks were used for the removal of the 4 ft or so of red soil over-burden in advance of the quarrying of the ironstone rock. The ironstone stratum is about 20 ft thick on this part of the Edge Hill escarpment.

The soil over-burden was taken back towards the Camp Lane Bridge and then tipped on the eastern side to form an embankment to take the spur track to Nadbury Camp. This ancient site was to be quarried away and the track then extended towards Warmington.

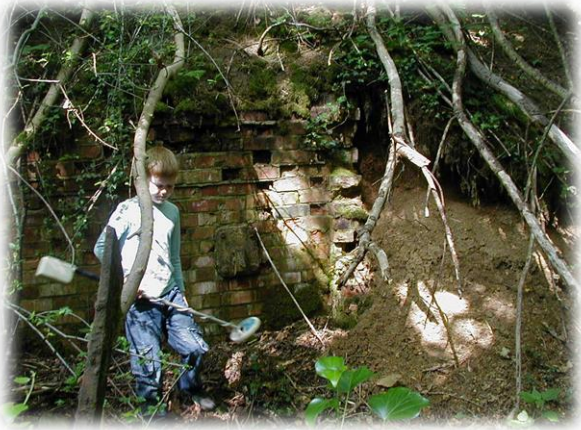
Remains of the linesman's hut at the top of the incline. The brickwork shows one bracket that held the rods that worked the points. The brickwork formed a small square room at ground level, and only the back wall remains. The hut was set on top of this brick room.

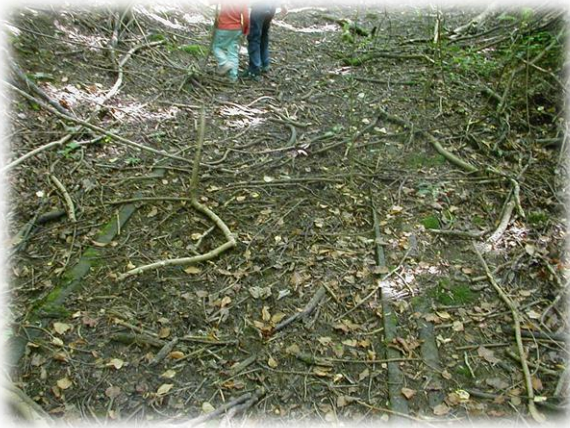
Points at the top of the incline. The track was standard gauge as for main line railways.

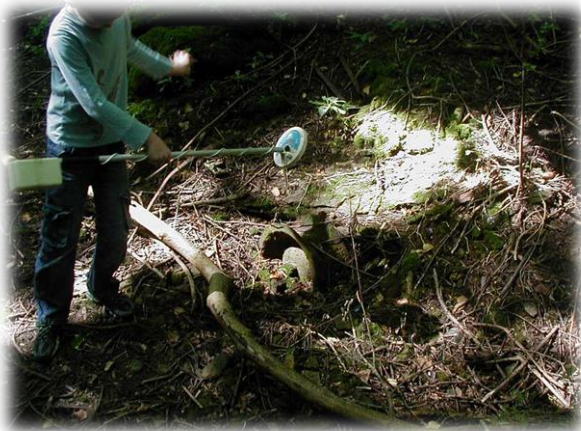
The railway on the incline was rope operated. Loaded trucks going down the incline pulled empty trucks up the incline. The steel wire rope was guided by rollers. One still remains on site.

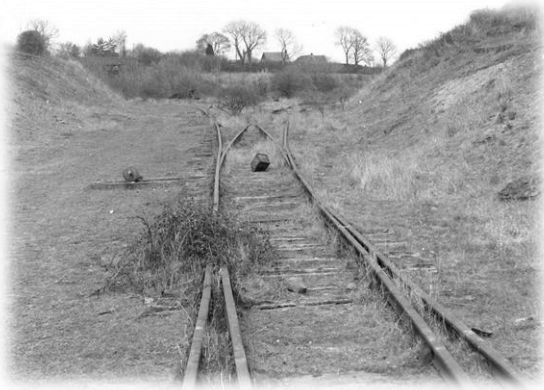
These are the remains of the line from the quarry face towards the incline. Camp Lane bridge can just be seen on the left. The houses on Camp Lane can be seen on the horizon and the spur towards Nadbury Camp is on the right. The points are set for Nadbury Camp which might indicate the last task for the EHLR was tipping spoil to form the embankment - or possibly not. It is more likely that Ratley boys threw the points for fun.

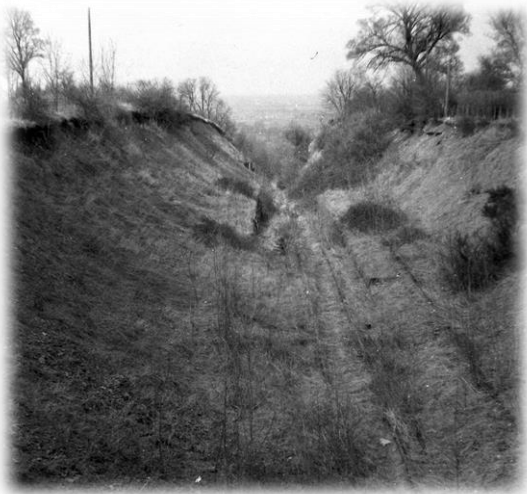
This was the view from Camp Lane Bridge looking north towards the incline. It was a very deep cutting that is completely overgrown now. The remains of the linesman's hut can be seen on the left. The telegraph poles were for communication between the brake man on the top wheels, the linesman here and the other linesmen further down. Three tracks can be seen, they are the same ones that passed over the wheel pit.

Once the loaded wagons were ready to roll, which were positioned close to this linesman's hut, the linesman here would have sent over the phones a command such as "all clear above and below?" and only when a satisfactory response was received from all parties, the iron stop blocks were rotated away from the wheels of the first wagon and then the brakesman eased on the brakes at the wheel pit. It is probable that a hooter sounded as well as a warning.

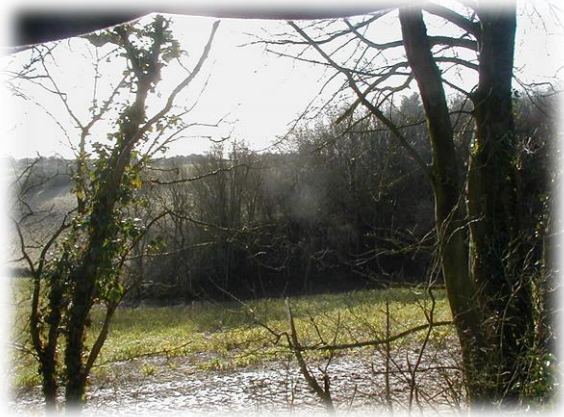
This shows the embankment for the Nadbury Camp spur. It can just be seen through the trees at the bottom of the slope. It was formed from the waste overburden on top of the ironstone stratum. It still had a long way to go. A survey needs to be undertaken to see if it is up to its final height, which it probably is not, as Nadbury Camp is at the same level as the photographer.
